Bendix™ VORAD® VS-400 Radar System

Troubleshooting Guide

Bendix™ VORAD® Collision Warning System
Bendix™ SmartCruise® Adaptive Cruise Control
Bendix™ BlindSpotter® Side Object Detection
BW2771 (Formerly VOTS0100)

June 2012

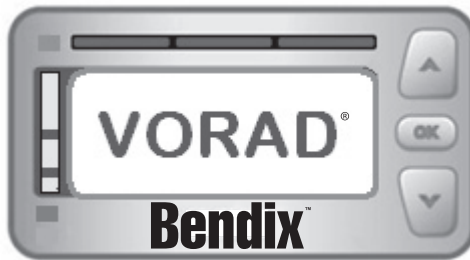
With the vehicle's ignition turned to the ON position (Engine OFF), observe the power-up sequence of the VS-400 Driver Interface Unit (DIU).

VS-400 DIU Lamp Test at initial power-up

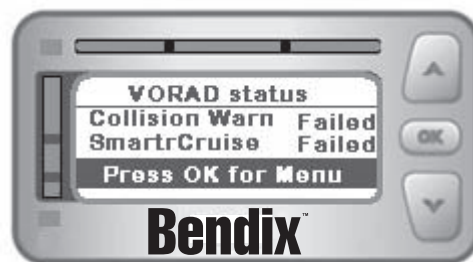
After about 30 seconds from when the ignition was powered on, the DIU should display the VORAD status screen. This screen will display which functions are enabled and if that function's operation is OK or Failed.

If a function has failed, the orange Diagnostic Trouble Code (DTC) lamp will be illuminated, indicating an Active code has been set. Proceed to the Retrieving Diagnostic Trouble Codes (DTCs) section.

VORAD status screen showing both Collision Warning System and Bendix SmartCruise® enabled but failed

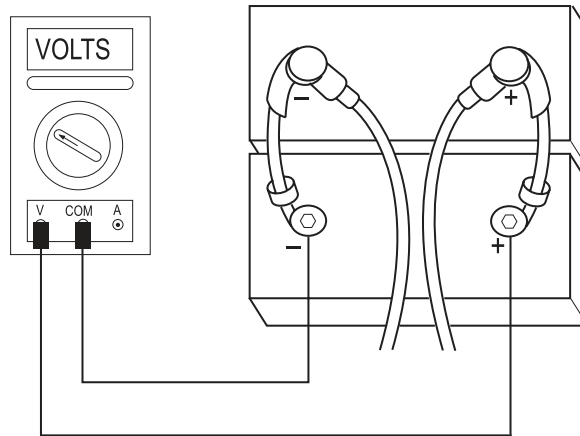
Step	Procedure
A	<ol style="list-style-type: none">1. Vehicle Ignition: Key-ON, Engine-OFF.2. Measure and record the vehicle battery voltage at the battery terminals.<ol style="list-style-type: none">a. If the battery voltage measures within 2 volts of the battery-rated voltage. (10-12 volts for a 12-volt battery)<ol style="list-style-type: none">i. Proceed to Step Bb. If the battery voltage measures less than 2 volts of the battery-rated voltage. (less than 10 volts for a 12-volt battery)<ol style="list-style-type: none">i. Test Failed. Check batteries and charging system for proper operation, repair as required. Repeat Step.

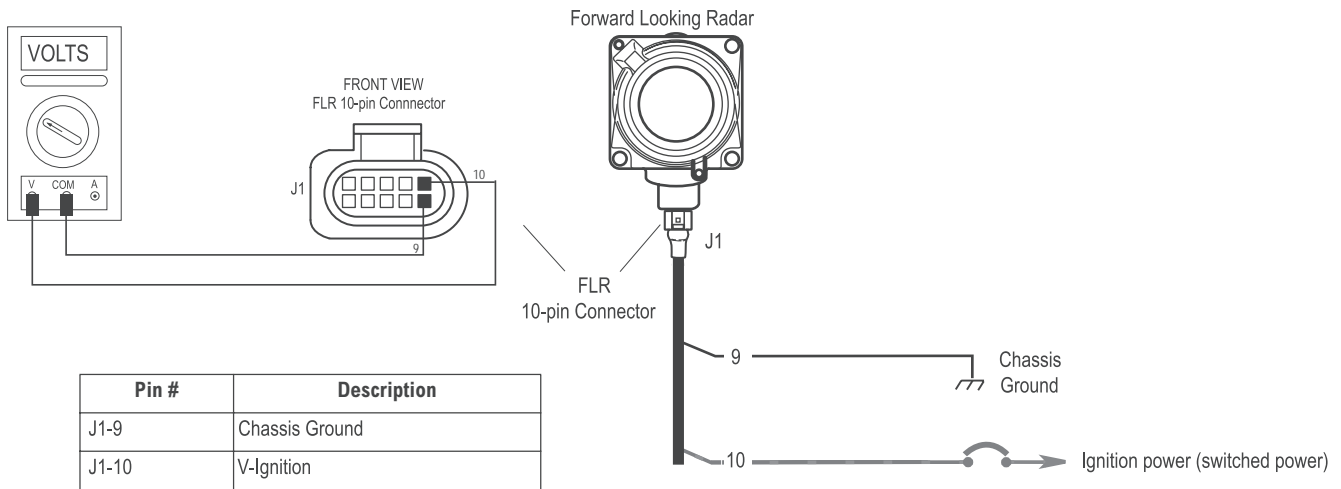
Step	Procedure
H	<ol style="list-style-type: none"> 1. Vehicle Ignition: Key-OFF, Engine-OFF. 2. Disconnect the 10-way connector from the VS-400 Forward Looking Radar (FLR). 3. Measure for zero voltage on pins 10 and 9 on the harness connector. <ol style="list-style-type: none"> a. If the voltage is 0.5 volts or less. <ol style="list-style-type: none"> i. Proceed to Step I. b. If the vehicle is greater than 0.5 volts, but less than battery voltage. <ol style="list-style-type: none"> i. Test Failed. Check FLR power supply wiring for sources of stray voltage or shorts to voltage. c. If the voltage is within 0.6 volts of the vehicle battery voltage measured in Step A: <ol style="list-style-type: none"> i. Test Failed. The FLR is improperly wired to battery power. Correct the wiring by connecting the FLR to ignition power and repeat Step.

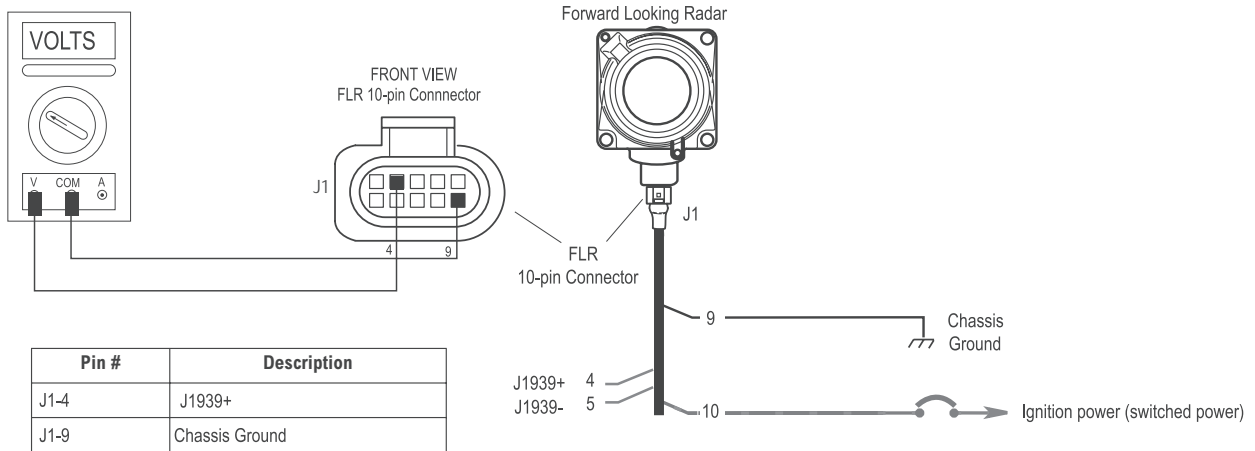
Step	Procedure
J	<ol style="list-style-type: none"> 1. Vehicle Ignition: Key-ON, Engine-OFF. 2. Measure for J1939 data voltage on pins 4 and 9 of the FLR harness connector. (J1939 High to Ground) <ol style="list-style-type: none"> a. If the voltage is fluctuating between 2 to 5 volts. <ol style="list-style-type: none"> i. Proceed to Step K. b. If the voltage is a constant 0 volts. <ol style="list-style-type: none"> i. Test Failed. Check for open / loose connections in the vehicle's J1939 data link harness. (See Note) <p>Note: Refer to vehicle OEM repair manual or contact the OEM for more information on the J1939 data link harness.</p>

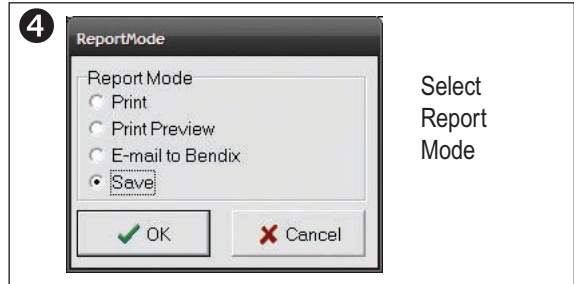
1. Bendix ACom Diagnostics 6.4 or higher is required for this procedure.
2. After the diagnostics tool has been successfully connected to the vehicle, the service technician will be presented with the window shown to the right. See Diagram 2.
3. Select "VORAD Data Log", then select "Start Data Log". See Diagram 2.
4. Select "Create Data Log Report". See diagram 1.
5. Enter the vehicle data (mileage, ID), select "Continue". See diagram 3.
6. Select the type of report you require ("Print", "Print Preview", "E-mail", or "Save"), then select "OK". See diagram 4.
7. After saving the report, if you wish to reset the log, select "yes".
